# Copper in Transit Study

Stephen Wright, P.Eng.  
Elizabeth Bryce, MD, FRCPC  
Marthe K. Charles, MD, FRCPC  
Edouard Asselin, Ph.D., P.Eng.  
Davood Nakhaie, Ph.D.  
Teresa Williams, Ph.D.

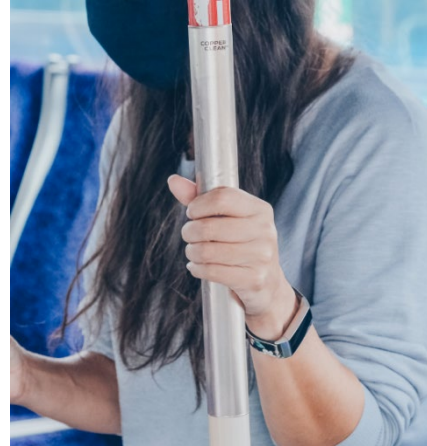
CopTek®, here on referred to as Cu decal, is an alloy adhesive patch that can be applied directly onto bus stanchions or other flat surfaces. This product has some slight differences from other available Cu decals that were initially considered, such as: Lower Cu content to reduce tarnishing, increased thickness for better durability, and higher glue strength to reduce vandalism.

Figure 2: Copper decal

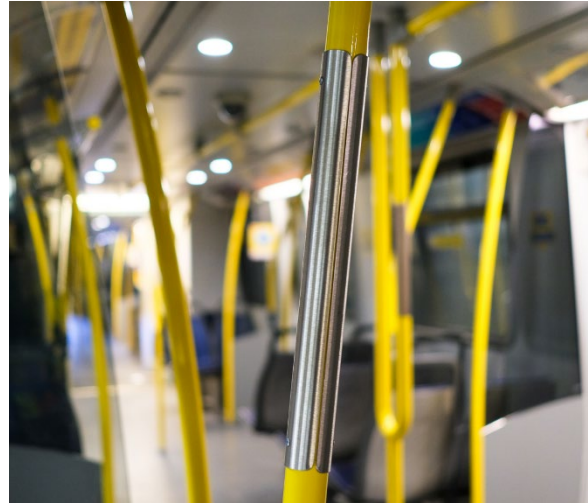
Trimco®, here on referred to as a Cu cover, was a custom-made copper alloy cover for stanchions. This product was expected to have the best durability as it was a solid metal cover; however, this was also the most expensive option. The potential for increased durability at a higher cost was of significant interest in evaluating this product.

Figure 3: Copper stanchion cover

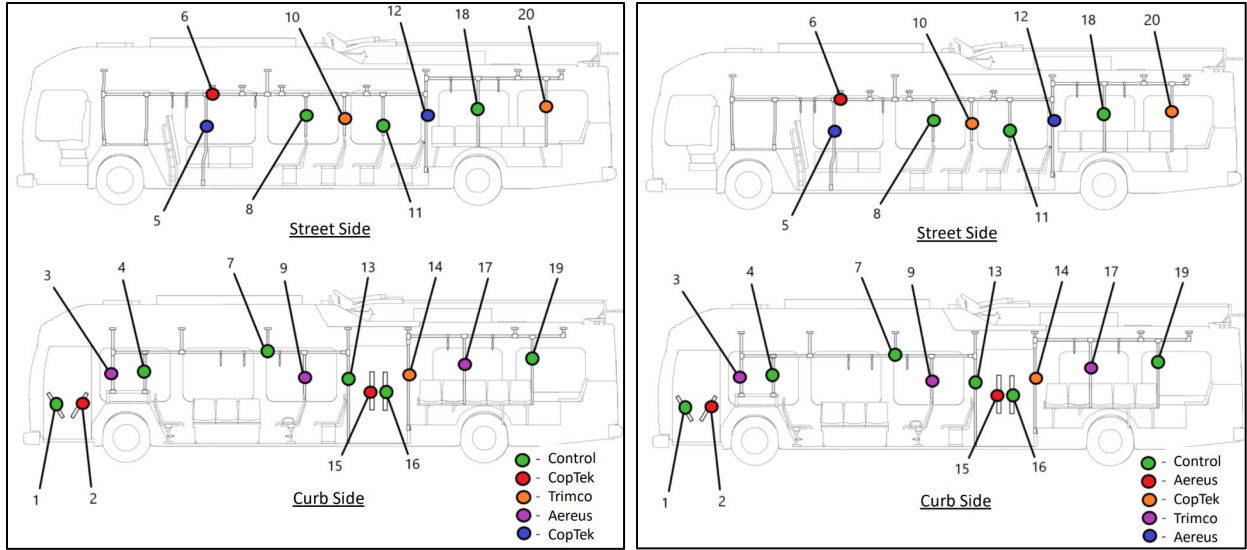
Vehicle types and sample points were selected early in the planning phase based on lessons learned in the three-month pilot study. Two key decisions were made to minimize potential study bias: a) the use of paired controls for Cu products and b) rotating the location of product types between test vehicles to reduce confounding due to varying levels of use that could occur for individual stanchions. Examples of two vehicle layouts are shown in Figure 4 to illustrate the paired controls and rotated product locations.

Standardized sampling points per vehicle were maximized, while avoiding locations that would have limited use in an effort to reduce this potential confounder. The number of vehicles was then selected to provide a full rotation of the three products between the different configurations.

Figure 4: CMBC bus 2108 (left) and 2124 (right) sample points

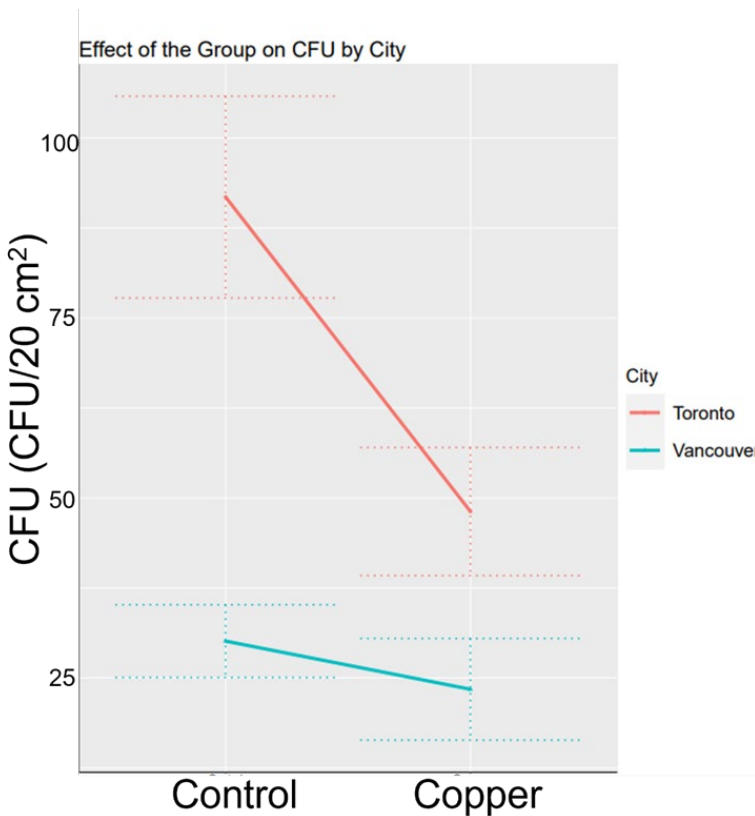
After 12 months of in-field use, the combination of all three Cu products exhibited a 42.7% reduction in the CFU compared to the control stanchions (Figure 8). [Toronto showed slightly better bactericidal effects of Cu compared to Vancouver.] Interestingly all transit vehicles in both locations had much lower bacterial numbers on the controls than what has been previously reported in the literature. The reasons for the lower control bacterial counts were likely multiple: a) reduced ridership during the pandemic; b) decreased bacteria on high-touch surfaces because of the use of both gloves and masks (reducing bacterial deposition on surfaces) and c) a general avoidance of touching potentially contaminated surfaces. The reduced bacterial count on the control samplings likely served to underestimate the antimicrobial effects of Cu.

Figure 8: The effect of Cu compared to the control stanchions on the CFU counts after 12 months of in-vehicle use

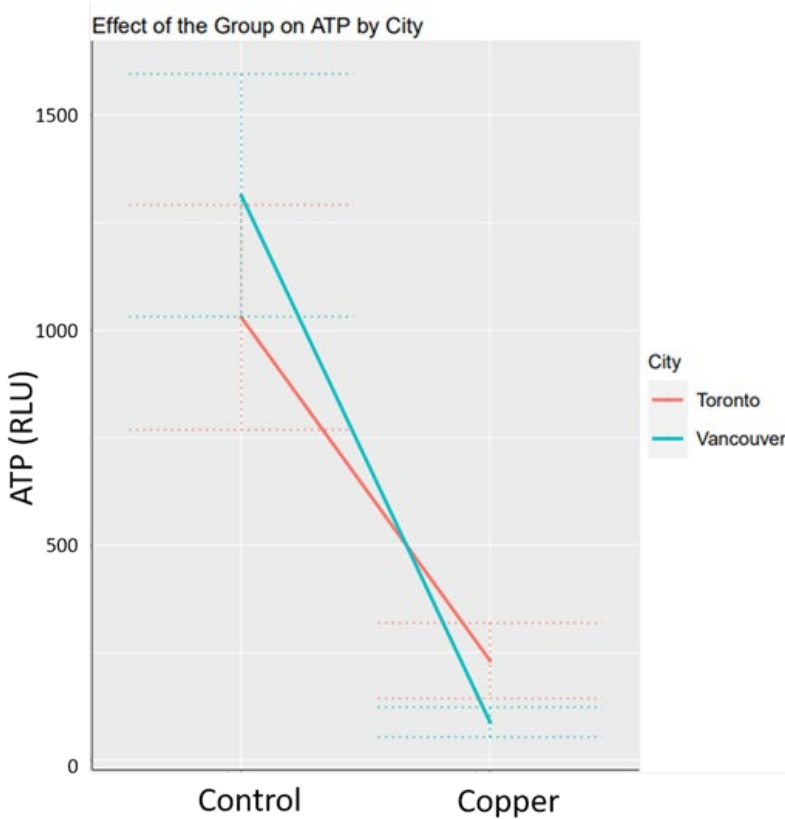
All Cu products in both locations demonstrated an average 87.1% reduction in the mean ATP levels, read as relative light units (RLU). In contrast to what was observed with CFU counts, Vancouver displayed higher average RLU values, and a greater percent reduction compared to Toronto, shown in Figure 9. The reason for this is unclear but may reflect the difference in humidity and temperature that occurs seasonally in both locations.

Figure 9: The effect of Cu compared to the control stanchions on the ATP RLU counts after 12 months of in-vehicle use

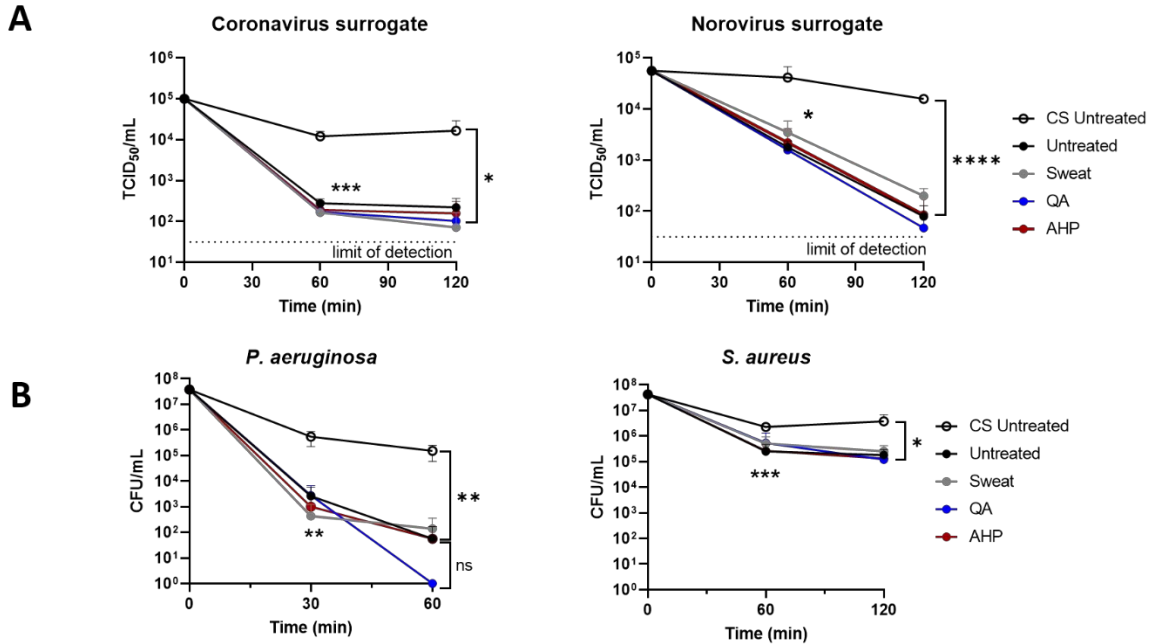
Figure 10A illustrates the accumulative results of all Cu products compared to the untreated controls. All Cu products showed excellent antiviral efficacy against the norovirus and coronavirus surrogates after two hours, regardless of disinfectant used in the 200-rounds of simulated cleaning or with the application of artificial sweat. Cu products killed on average 97.5% of the coronavirus surrogate by two hours with most of the antiviral activity occurring within the first hour. The human norovirus surrogate had a slower time-kill kinetic but demonstrated a 99.5% reduction in viral activity after two hours of exposure. This was consistent for all Cu products.

For bactericidal analysis, coupons were inoculated with *P. aeruginosa* or *S. aureus* in a range of  $3.8\text{-}4.3 \times 10^7$  CFU/mL in a simulated soil inoculum. For *P. aeruginosa* the inoculum was collected at 30 minutes and one hour as Cu is known to be most efficacious against gram-negative bacteria. *S. aureus* is a gram-positive organism that is more resistant to Cu and therefore samples were collected at one and two hours. After one hour of Cu exposure 99.9% of *P. aeruginosa* was killed compared to the control (Figure 10B). Time-kill kinetics were slower for *S. aureus* however, after two hours between 89.9-99.9% of bacteria were killed for the various Cu products (Figure 10B). Synergy (enhanced bacterial killing) was observed with some disinfectants for both bacteria. The decals exhibited a higher killing efficacy with the AHP cleaner, and the Cu coating with the Quaternary ammonium disinfectant (individual data not shown).

Figure 10: Persistence of A) Coronavirus and Norovirus surrogate viruses and B) *P. aeruginosa* and *S. aureus* after 1 year of simulated use with disinfectants and artificial sweat compared to untreated copper coupons. (CS: yellow painted carbon steel; QA: quaternary ammonium disinfectant; AHP: Accelerated hydrogen peroxide disinfectant)

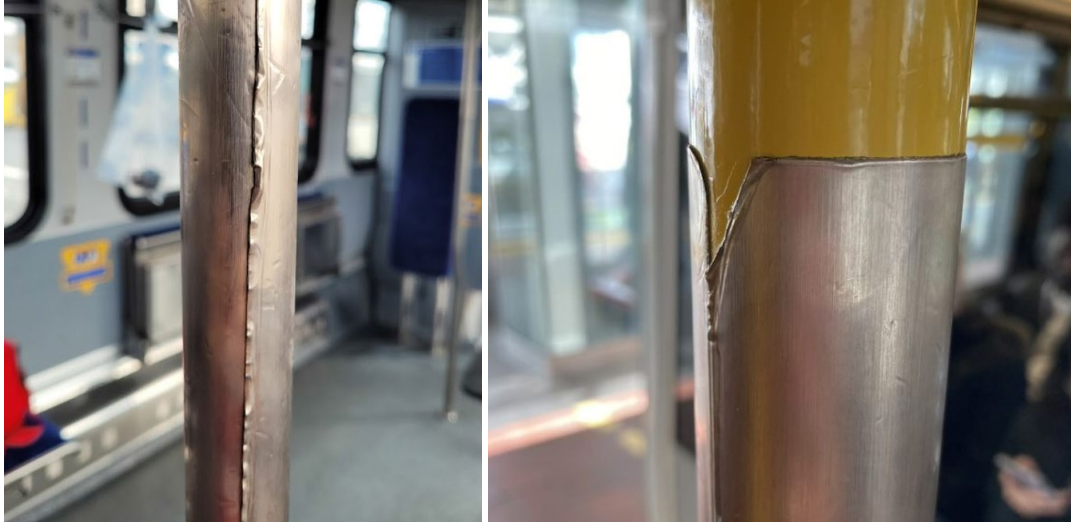
Once the decals had been damaged, they would be left with an exposed sharp edge, see Figure 11 below. TTC decided to remove all Cu decals from vehicles in March 2022, halfway through the trial, as the sharp edge and frequency of vandalism in Toronto presented a safety risk for hand injuries.

Figure 11: Copper decal vandalism

While both the Cu coating and Cu cover handled the abuse of daily transit better than expected, with no test points requiring replacement during the 1-year period, the Cu decal did have significant issues with vandalism. Over the length of the trial, 20 decals had been vandalized by passengers picking at the seam in an attempt to remove it. A high strength glue was added to the decal seam part way through the trial to reduce vandalism; however, incidents continued to occur.

Potential sharp edges should be considered and minimized when installing antimicrobial Cu products. During the study there were two sources of sharp edges: vandalized/peeling decals and poorly matched metal covers. While this was identified as a risk, there were no hand injuries reported during the study.

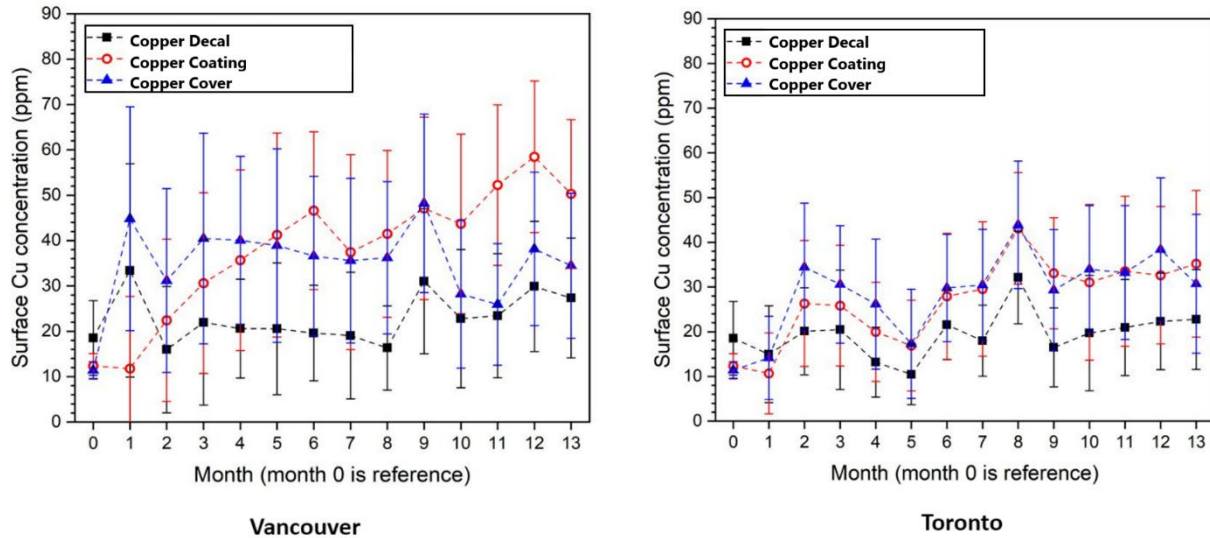
Figure 13 illustrates the evolving average surface Cu concentration over time for the three products installed. These measurements were acquired using the Waterloo Copper Concentration Kit<sup>6</sup>, where a greater Cu concentration signifies a more pronounced release of ions from the product's surface. Notably, the Cu products situated within Vancouver's public transit network consistently display elevated concentrations in comparison to their counterparts in Toronto's public transit system. This variation can be ascribed, at least in part, to the relatively warmer climate and heightened relative humidity prevalent in Vancouver, conditions that facilitate the release of Cu ions.

Figure 13: Average surface copper concentration for three different copper products determined from Waterloo Copper Concentration Kit
